Petrographic Inspection Report

Title: Petrographic Inspection Report for Penrice Quarry Aggregate

Prepared for: Penrice Quarry

Sample Description: 14mm Aggregate

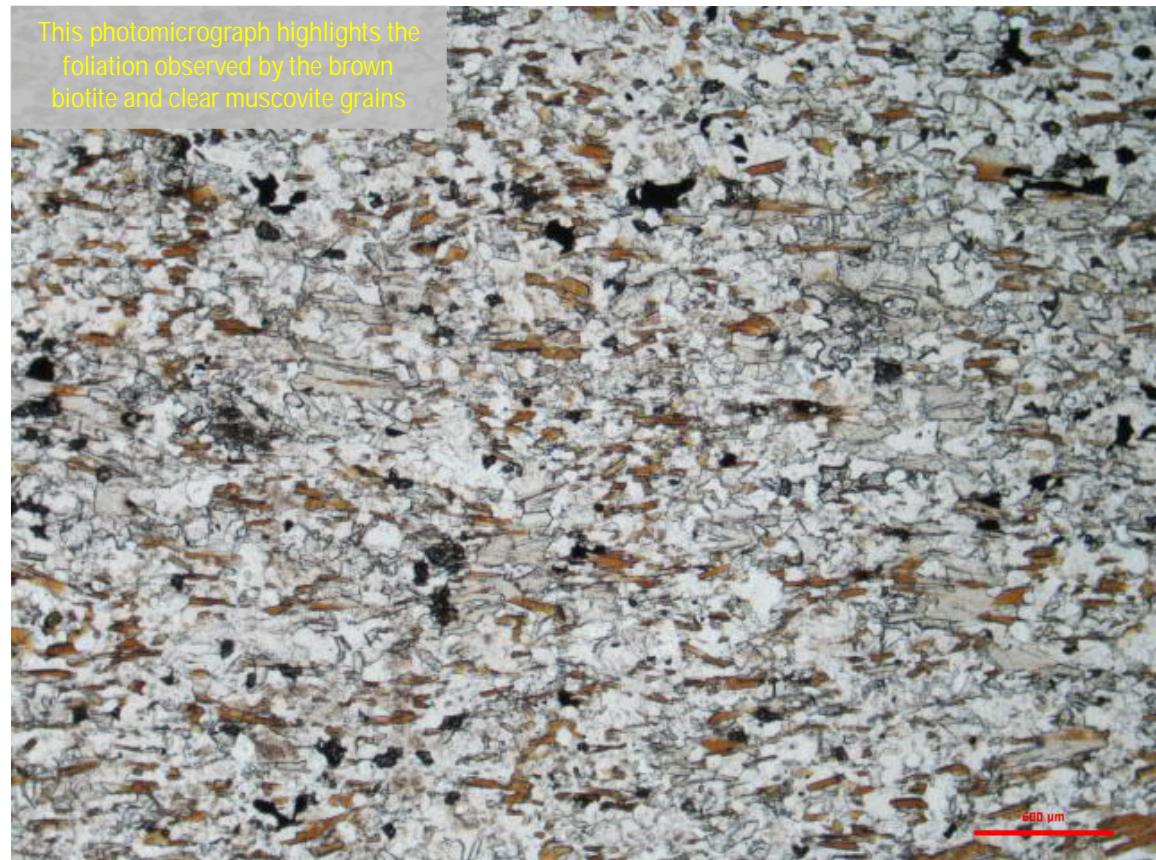
Plate 5: Microphotograph of the biotite schist lithology at 40x magnification utilising plane polarised light. Scale = 500um x 40 magnification. F.O.V 5.2mm.
